SALT LAKE CITY HISTORIC LANDSCAPES REPORT Executive Summary

Artesian Well Pocket Park

SLCHLR NO. 15

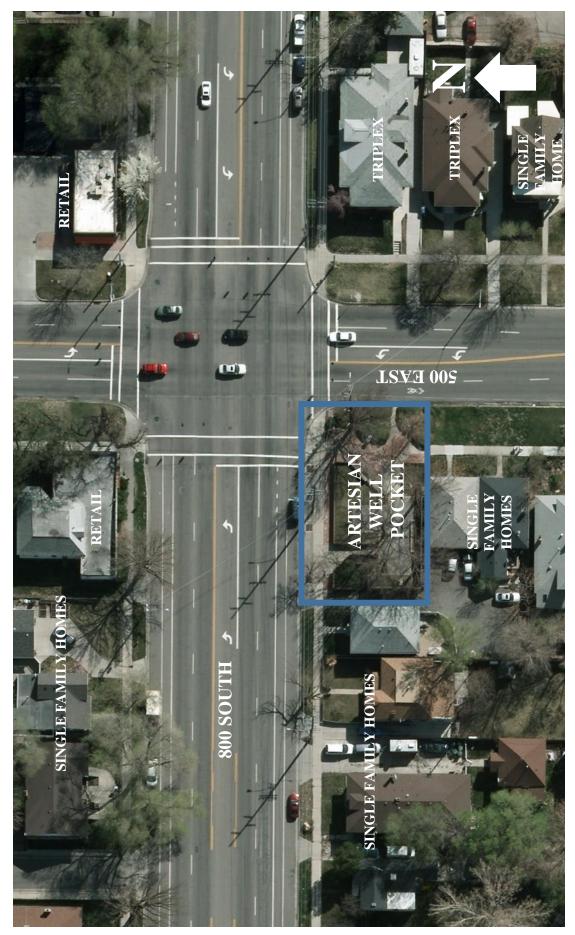
Fig. 2. Context Map (2012).

Located on a corner lot, the Artesian Well Pocket Park is accessed from both the 500 East and 800 frontages via four specific entrance points. Primary pedestrian access to the rectangular-shaped park is from the southwest corner of the intersection at 500 East 800 South. A secondary access is located along 800 South, with two more from the 500 East frontage. The surrounding area is relatively flat. One-hour vehicular parking is allowed along 800 South (see fig. 2).

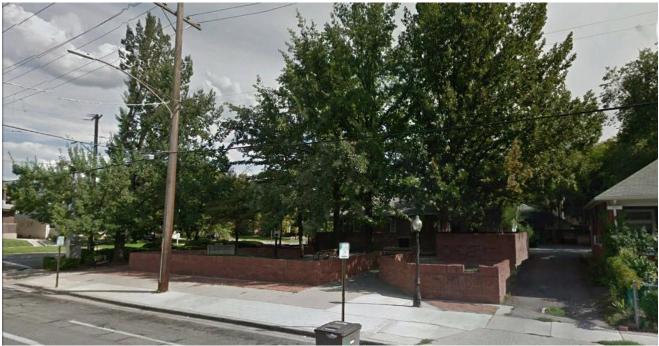
The northwest entrance, located along 800 South, is defined by a red brick wall. A decorative metal light fixture is located west of this entrance. Red and grey brick pavers and two types of exposed aggregate concrete paving run the length of the walkway along 800 South (see figs. 3-5).

Fig. 3. Street view to the southeast looking into the park on 800 South. Note the brick retaining wall running the length of 800 South and continuing around the western perimeter and the varied brick and concrete walkway surfacing along the frontage of 800 South (Google).

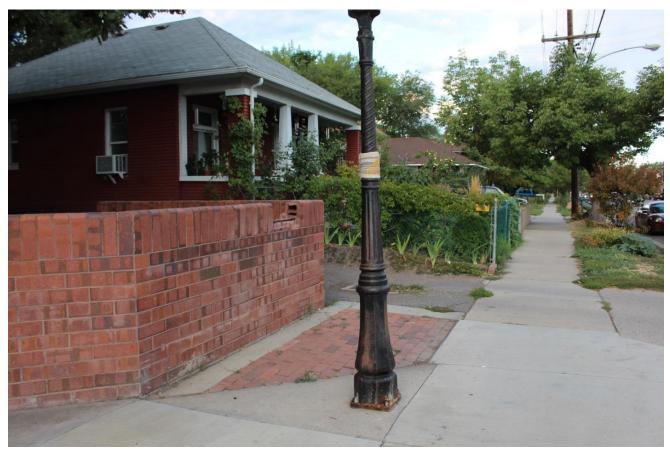
Fig. 4. Decorative metal light fixture located west of the northwest entrance of the park along 800 South. Note the single family housing to the west, the brick wall and pavement detail (Siri Vlasic, 9/1/15).

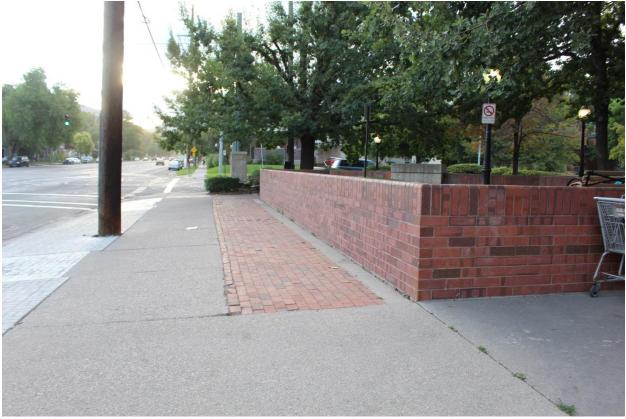
Fig. 5. A brick retaining wall marks the 800 South entrance frontage. Photograph taken facing east. Note the grey and red brick and exposed aggregate concrete pavement detail (Siri Vlasic, 9/1/15).

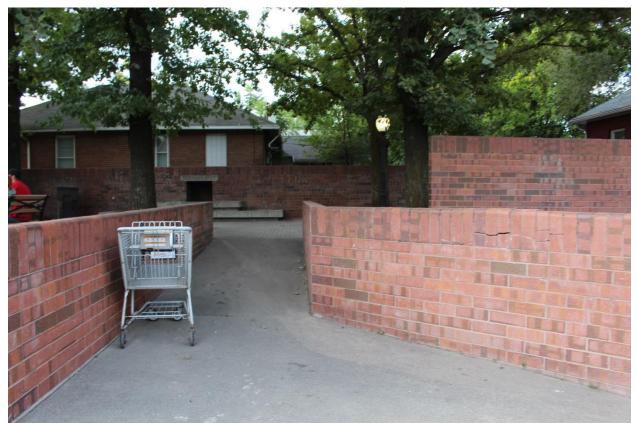
Fig. 6. View to the south of the northwest entrance into the park on 800 South (Siri Vlasic, 9/1/15).

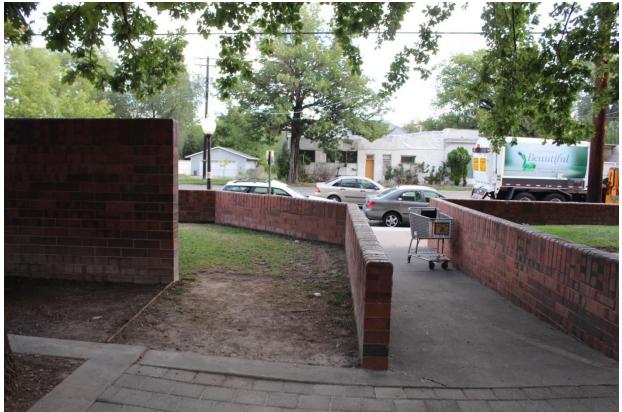
Fig. 7. View to the north from inside the northwest entrance of the park facing 800 South. Note the semienclosed grassed area to the left and to the far north across the street an abandoned retail store (Siri Vlasic, 9/1/15).

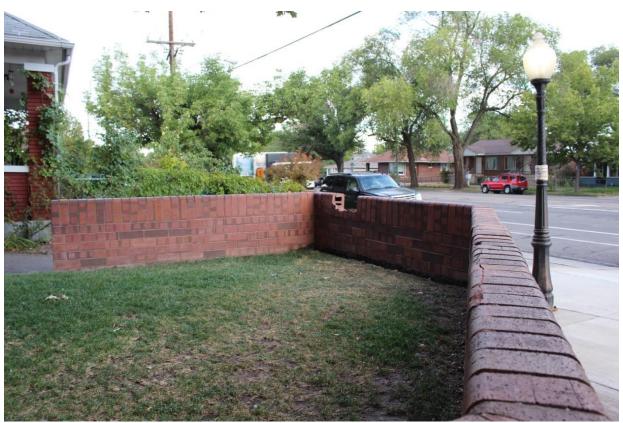
Fig. 8. View to the northwest from inside the northwest entrance of the park facing toward 800 South. Note the single family housing across the street (Siri Vlasic, 9/1/15).

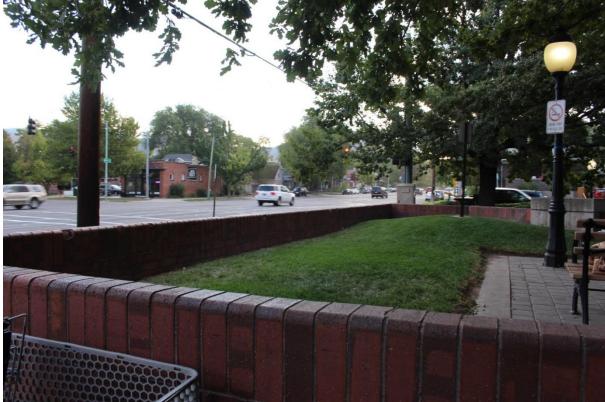
Fig. 9. View to the northeast from inside the northwest entrance of the park facing toward 800 South. Note the brick wall used for retaining and to the far northeast across the street a brick retail shop (Siri Vlasic, 9/1/15).

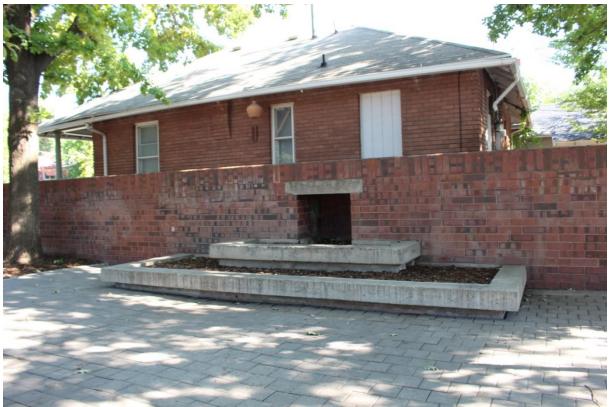
Fig. 10. Two-tiered concrete fountain repurposed into a planter located along the southern perimeter of the park in the southwest corner. Note the circa 1911 single family brick home in the background (Sanborn 1911) (Siri Vlasic, 9/1/15).

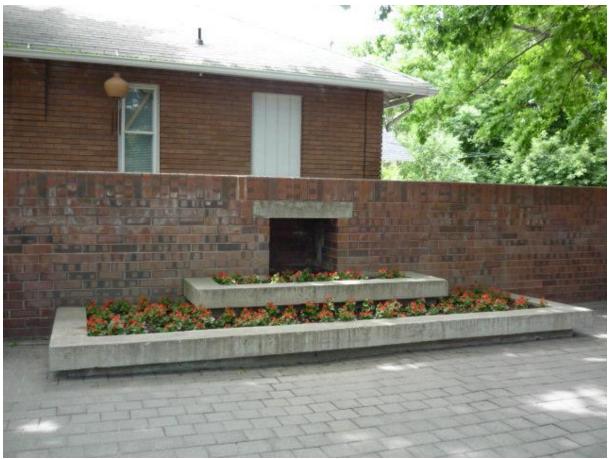
Fig 11. Two-tiered concrete planter filled with annuals in 2009 (Salt 1).

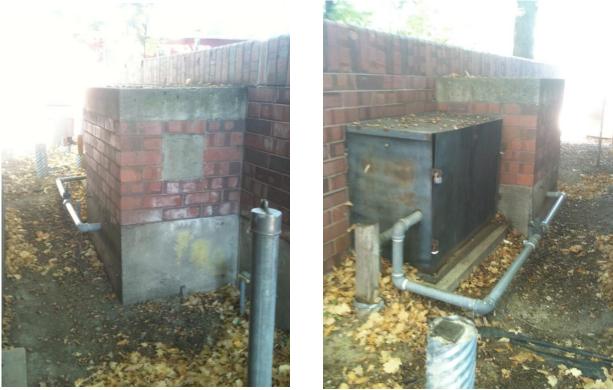
Fig. 12. South side of the brick wall and two-tiered planter along the southern perimeter of the park. Note the piping and pump casing (JoEllen Gandy, 10/23/15)

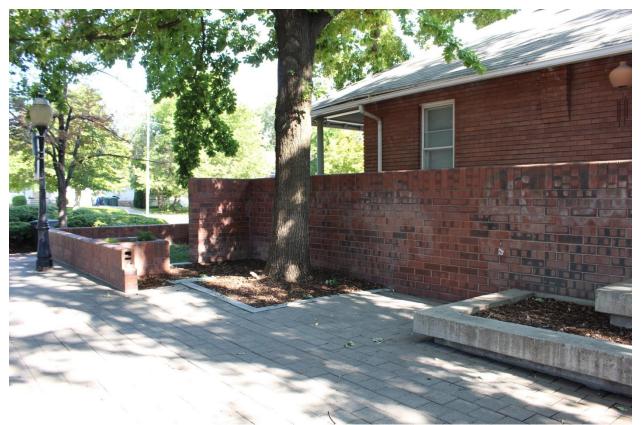
Fig. 13. View to the southeast of the courtyard and two-tiered concrete planter. Note the decorative metal light fixture, brick mini planter box and Oak tree (*Quercus sp.*) to the far left (Siri Vlasic, 9/1/15).

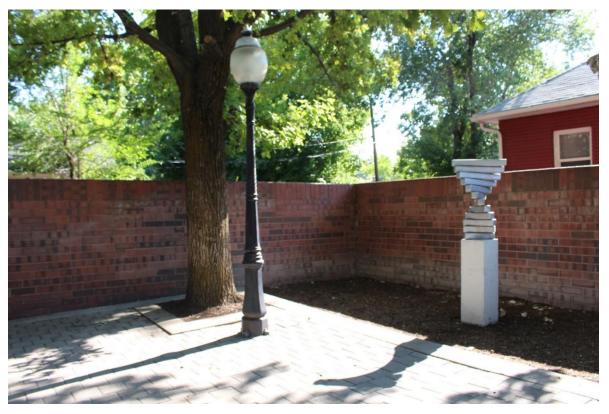
Fig. 14. View to the southwest of the park. Note the Oak tree (*Quercus sp.*), decorative metal acorn light fixture and abstract sculpture to the right (Siri Vlasic, 9/1/15).

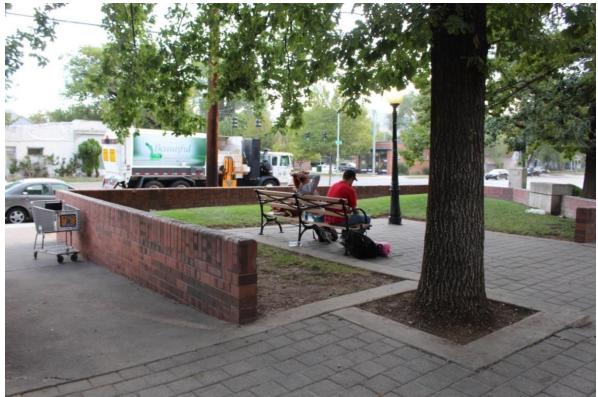
Fig. 15. A raised seating area marks the east edge of the northwest entrance of the park and west edge of the artesian well. Photograph taken facing northeast. Note the change in concrete to rectangle pavers outlined with concrete trim, decorative metal light fixture and the rear side of the artesian well to the right (Siri Vlasic, 9/1/15).

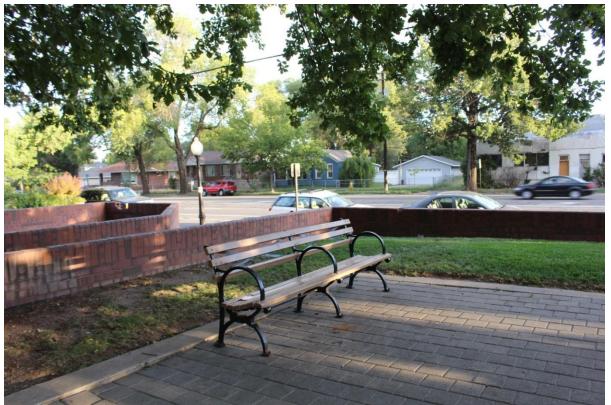
Fig. 16. Decorative wooden and metal bench marks the west edge the raised seating area (Siri Vlasic, 9/1/15).

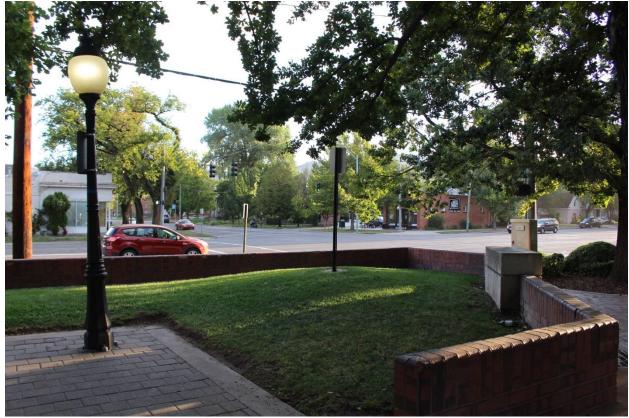
Fig. 17. Decorative metal light fixture, brick retaining wall and rear side of the artesian well mark the east edge of the seating area (Siri Vlasic, 9/1/15).

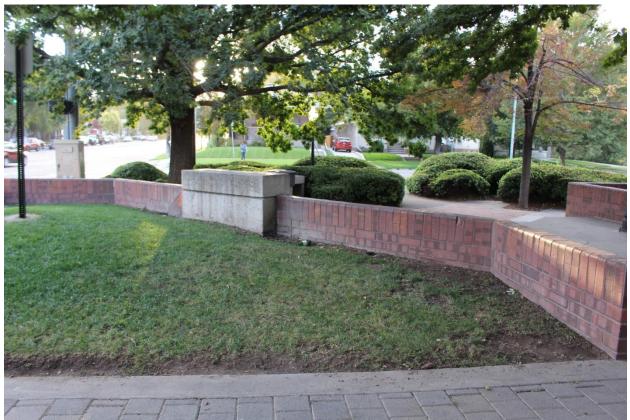
Fig. 18. View to the east of rear side of the artesian well (Siri Vlasic, 9/1/15).

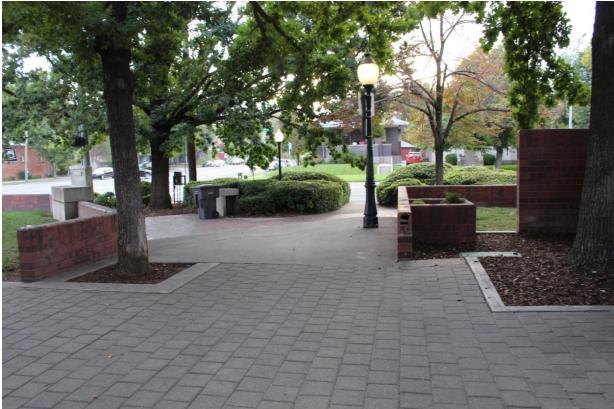
Fig. 19. View to the east from inside the park, south of the seating area, facing toward the east entrance into the park along 500 East (Siri Vlasic, 9/1/15).

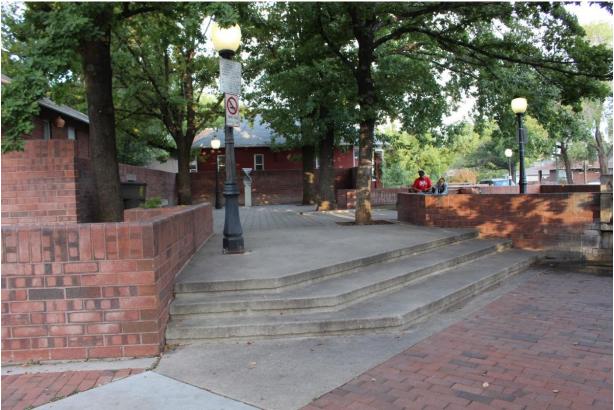
Fig. 20. View to the west from inside the park near the east entrance of the park along 500 East. Note the change in pavers between the upper and lower level, and the light fixtures, Oak trees (*Quercus sp.*) and sculpture to the far rear (Siri Vlasic, 9/1/15).

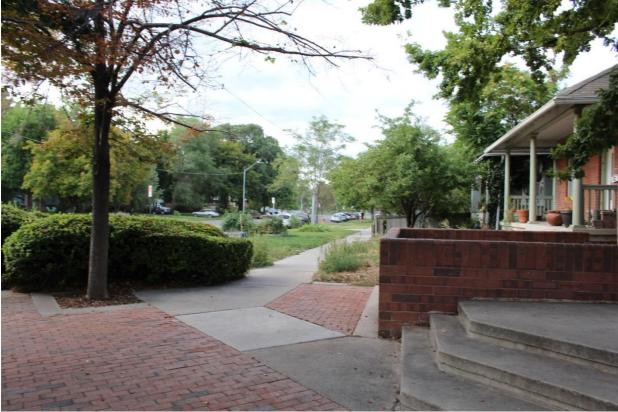
Fig. 21. View to the south from inside the south entrance of the park along 500 East's sidewalk (Siri Vlasic, 9/1/15).

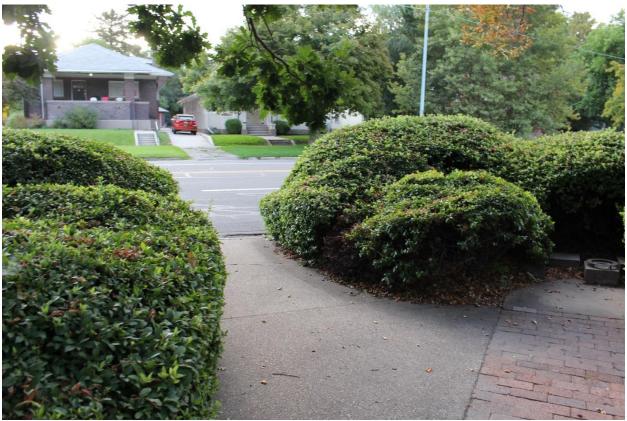
Fig. 22. View to the east from inside the east entrance of the park facing toward 500 East (Siri Vlasic, 9/1/15).

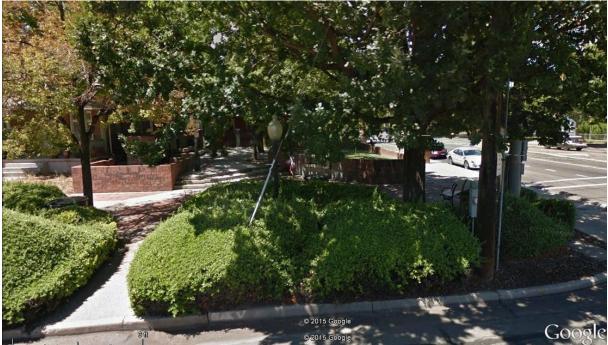
Fig. 23. View to the west of the east entrance into the park from 500 East. Note Pyracantha shrubs (*Pyracantha sp.*) flanked on each side of the walkway (Google).

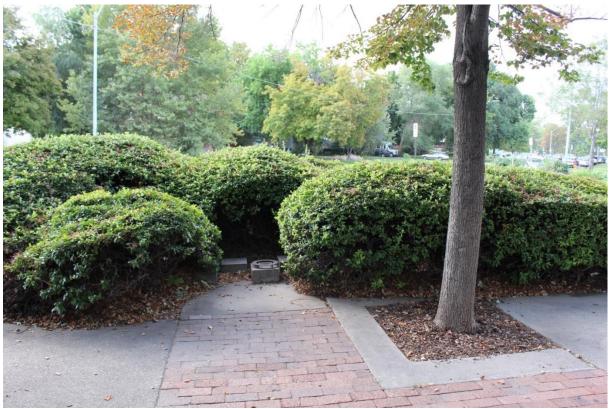
Fig. 24. Pyracantha shrubs (*Pyracantha sp.*) border the eastern edge of the park. Note the Linden tree (*Tilia sp.*) to the right (Siri Vlasic, 9/1/15).

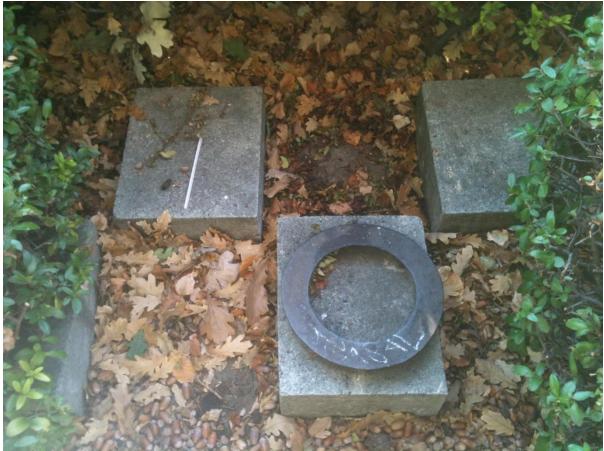
Fig. 25. Four concrete rectangular blocks nestled among Pyracantha shrubs (*Pyracantha sp.*) (JoEllen Grandy, 10/23/15).

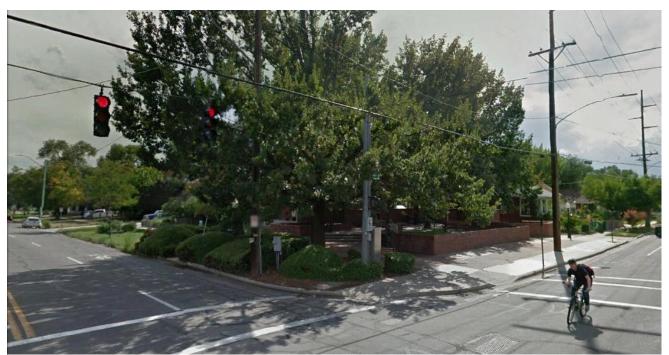
Fig. 26. Street view to the southwest of the main entrance into the park on the corner of 500 East and 800 South (Google)

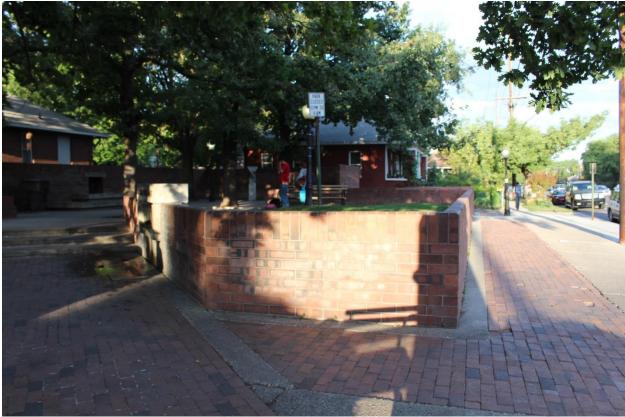
The main entrance into the park is located at the southwest corner of 500 East and 800 South. Along the west edge of the entrance, a brick wall encases the artesian well. Numerous minerals are documented to flow from the well, which has total dissolved solids between 700 - 100,000 parts per million. In 1936 from January to December, the well was reported to flow at rates of 2-20 gallon per minute from a 2-inch well case located at a well depth of 130 feet. Today, three spigots flow from the well casing, the overflow constantly emptying into a drain below. A French drain is also located at the base to catch spills (see figs. 26-30) (800).

Fig. 27. View to the southwest inside the main entrance into the park on the corner of 500 East and 800 South. Note the artesian well along the brick wall (Siri Vlasic, 9/1/15).

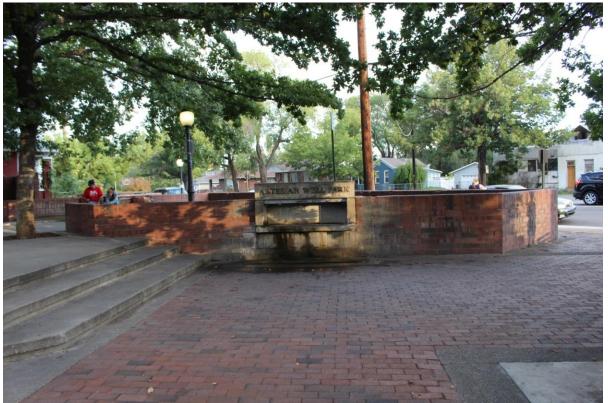
Fig. 28. View to the northwest of the artesian well and mini courtyard. Note the change in surfacing from concrete to brick pavers (Siri Vlasic, 9/1/15).

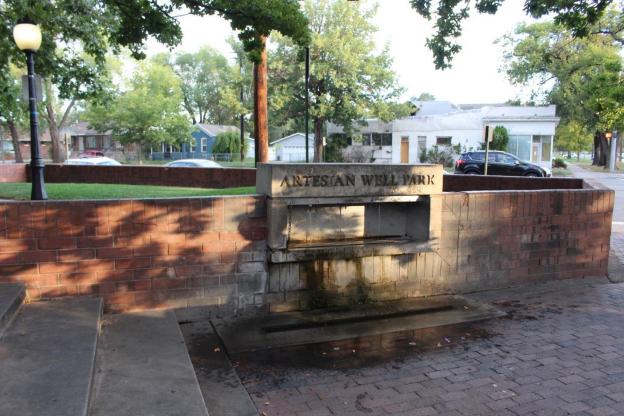
Fig. 29. View to the northwest of the artesian well (Siri Vlasic, 9/1/15).

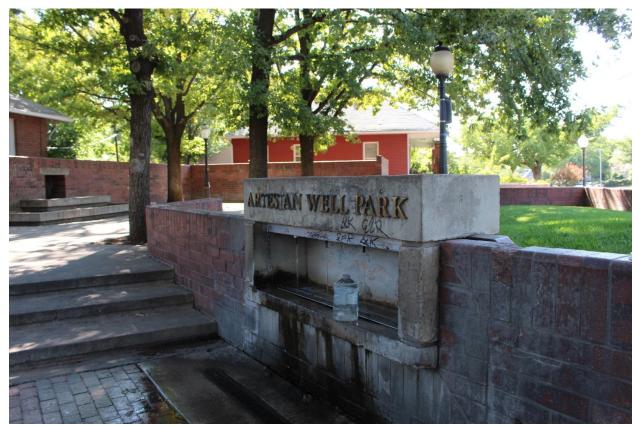
Fig. 30. View to the southwest of the artesian well (Siri Vlasic, 9/1/15).

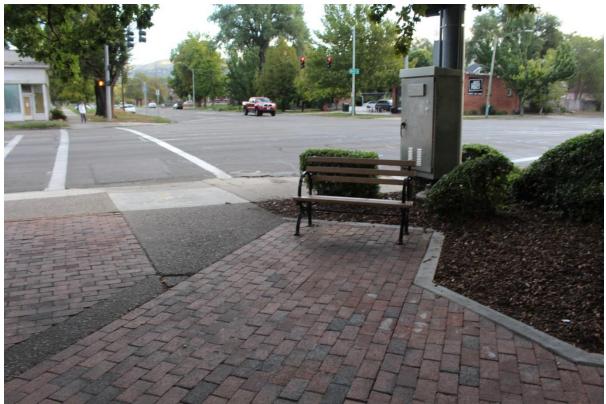
Fig. 31. View to the northeast inside the main entrance into the park on the corner of 500 East and 800 South. Note the decorative wooden and metal bench (Siri Vlasic, 9/1/15).

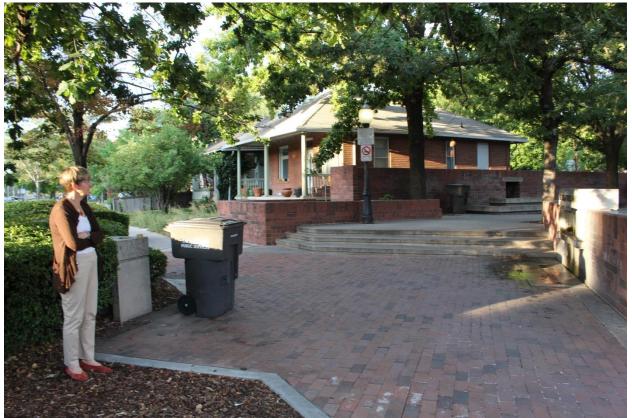
Fig. 32. View to the southwest inside the main entrance into the park on the corner of 500 East and 800 South. Note the rectangular concrete drinking fountain to the left near the garbage dispenser (Siri Vlasic, 9/1/15).

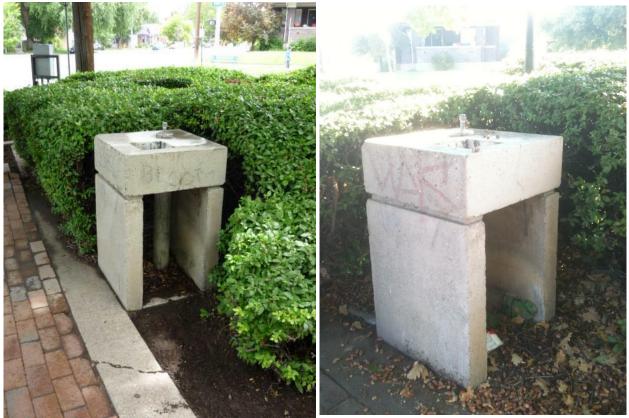
Along the east edge of the main entrance is an additional small wood and metal bench and rectangular concrete drinking fountain. The drinking fountain no longer functions and has fallen into disrepair (see figs. 31-33).

Fig. 33. Rectangular concrete drinking fountain in 2009 to the left; in 2015 to the right (Salt 7; JoEllen Grandy, 10/23/15).

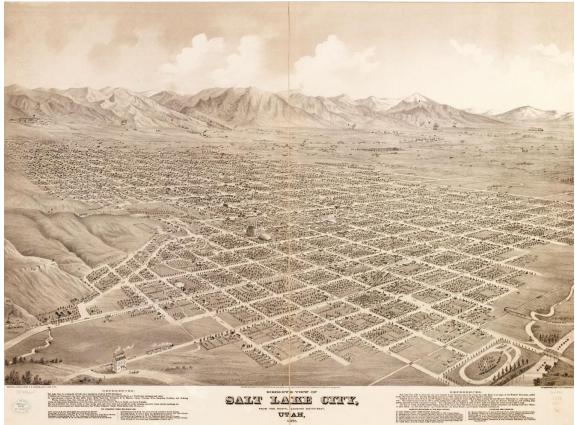
Fig. 34. An 1875 southeastern bird's eye view of Salt Lake City. Note the ten-acre block grid pattern patterned after the "Plat of the City of Zion". Map courtesy of Library of Congress, Geography and Map Division (Glover).

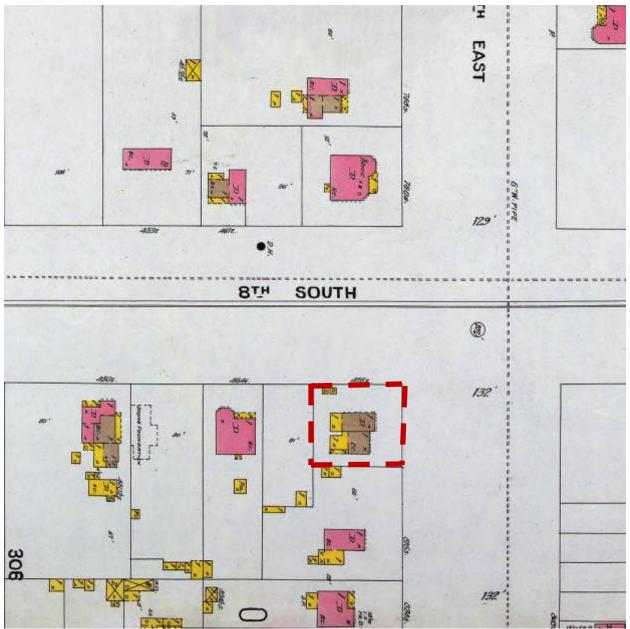
Fig. 36. 1898 Sanborn map illustrates the location of an adobe/fireproof and framed dwelling and detached outbuildings (Sanborn, 1898).

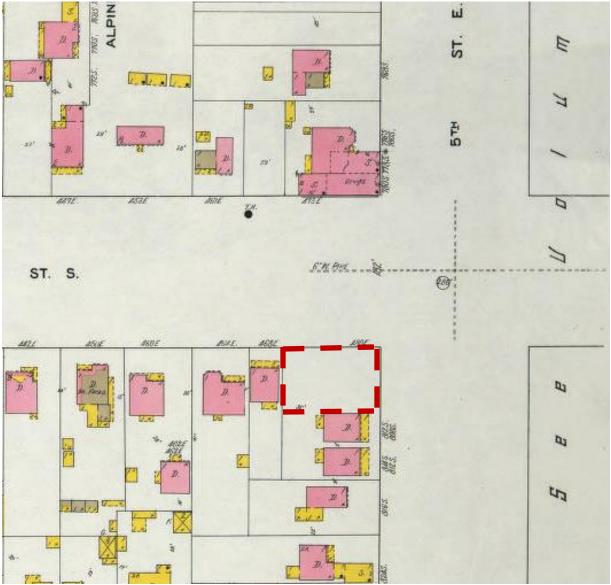
Fig. 37. 1911 Sanborn map illustrates the absence of the adobe/fireproof and framed dwelling and detached outbuildings, lot line adjustment, and the addition of two brick dwellings with framed porches. Note the southwest corner of 500 East 800 South is empty (Sanborn, 1911).

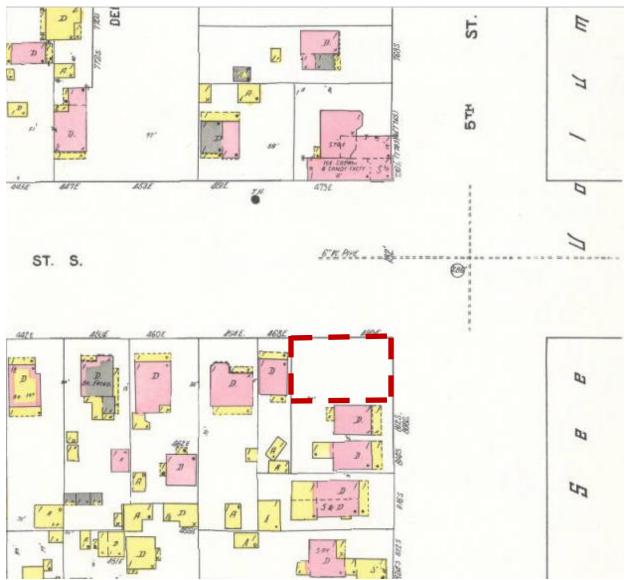
Fig. 38. 1950 Sanborn map illustrates continuation of two brick dwellings with a slight change in framed porches (Sanborn, 1950).

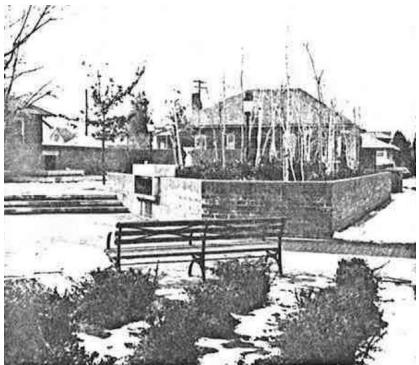
Fig. 40. Southwest view at the main entrance into the park on the corner of 500 East and 800 South in 1980. Note the large decorative wooden and metal bench and planting of Quaking Aspen trees (*Populus tremuloides*) in the raised seating area (802).

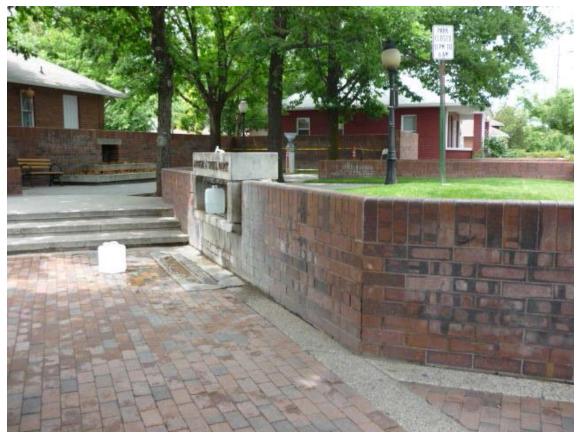
Today the well continues to run year-round and is a popular destination for many City residents and travelers around the Wasatch Front seeking natural water with high mineral contents and no chemicals. Park enhancements in 1979 were focused on formalizing the site into a small urban park, and are indicative of numerous similar small park projects instituted in the city during the same era. A small wood and metal bench used to be located next to the two-tiered planter in 2009, and was relocated in the park near the two-tiered planter (see fig. 41) (802).

Fig. 41. Southwest view inside the main entrance into the park on the corner of 500 East and 800 South in 2009. Note the decorative wooden and metal bench to the rear east of the two-tiered planter (Salt 6).

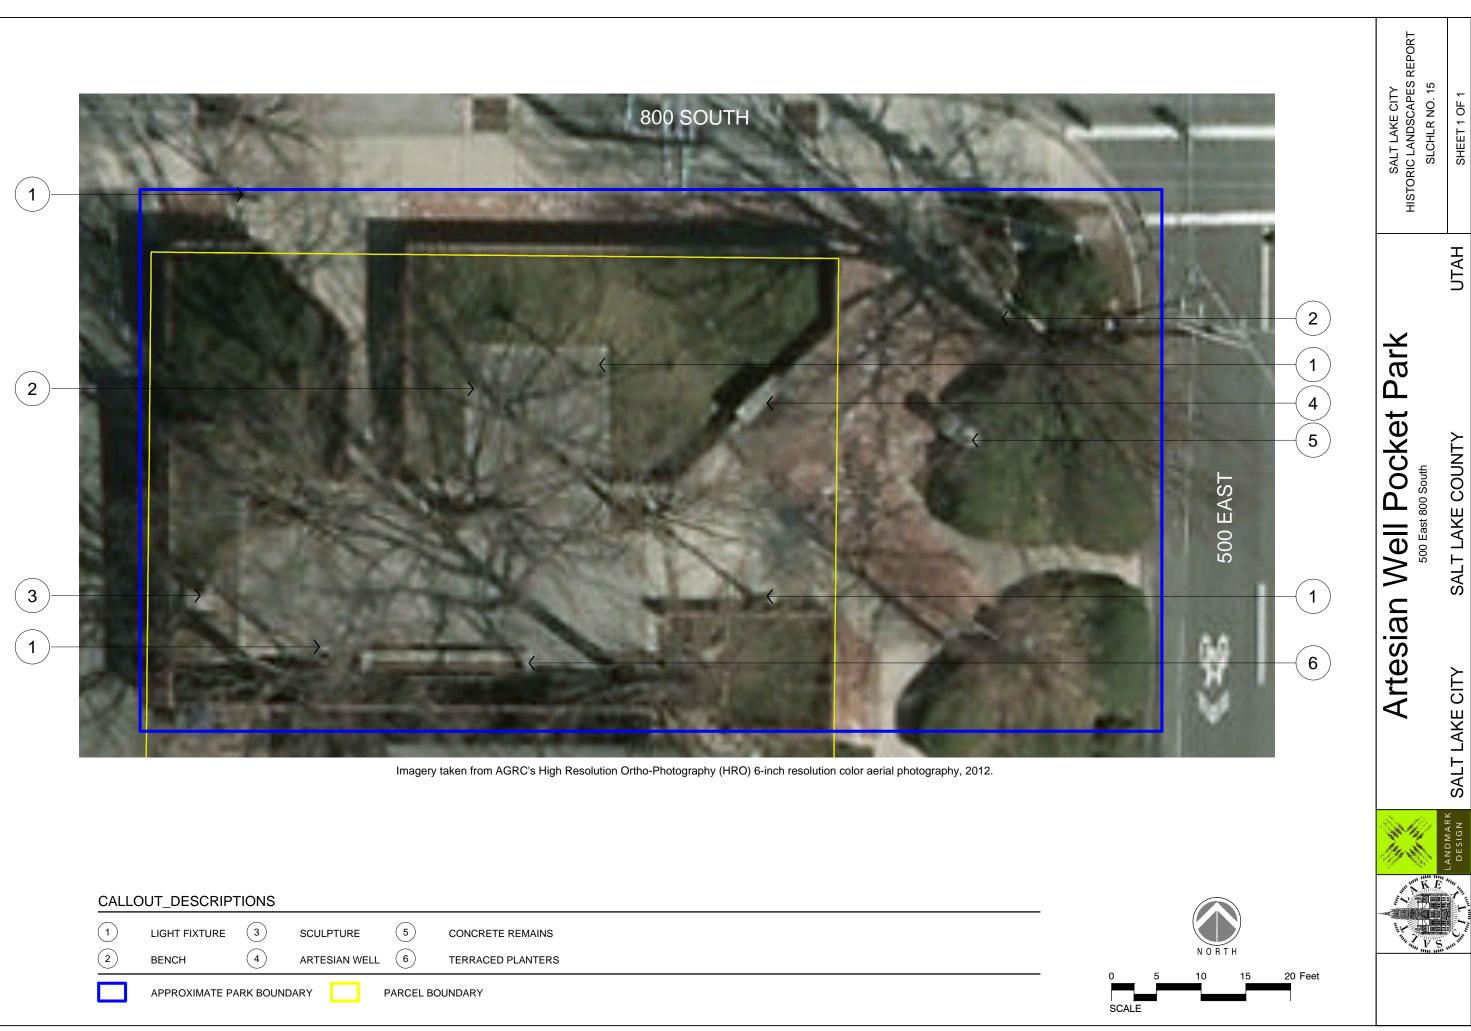
Fig. 42. See attached map of 2015 existing conditions of the Artesian Well Pocket Park.

1	LIGHT FIXTURE 3	SCULPTURE 5	CONCRETE REMAINS		
2	BENCH (4)	ARTESIAN WELL 6	TERRACED PLANTERS	_	
APPROXIMATE PARK BOUNDARY PARCEL BOUNDARY				0
